# NAVAL POSTGRADUATE SCHOOL

POSTBUCKLING BEHAVIOR  
OF GRAPHITE/EPOXY CLOTH SHEAR PANELS  
WITH 45°-FLANGED LIGHTENING HOLES

Richard John Herman

March 1982

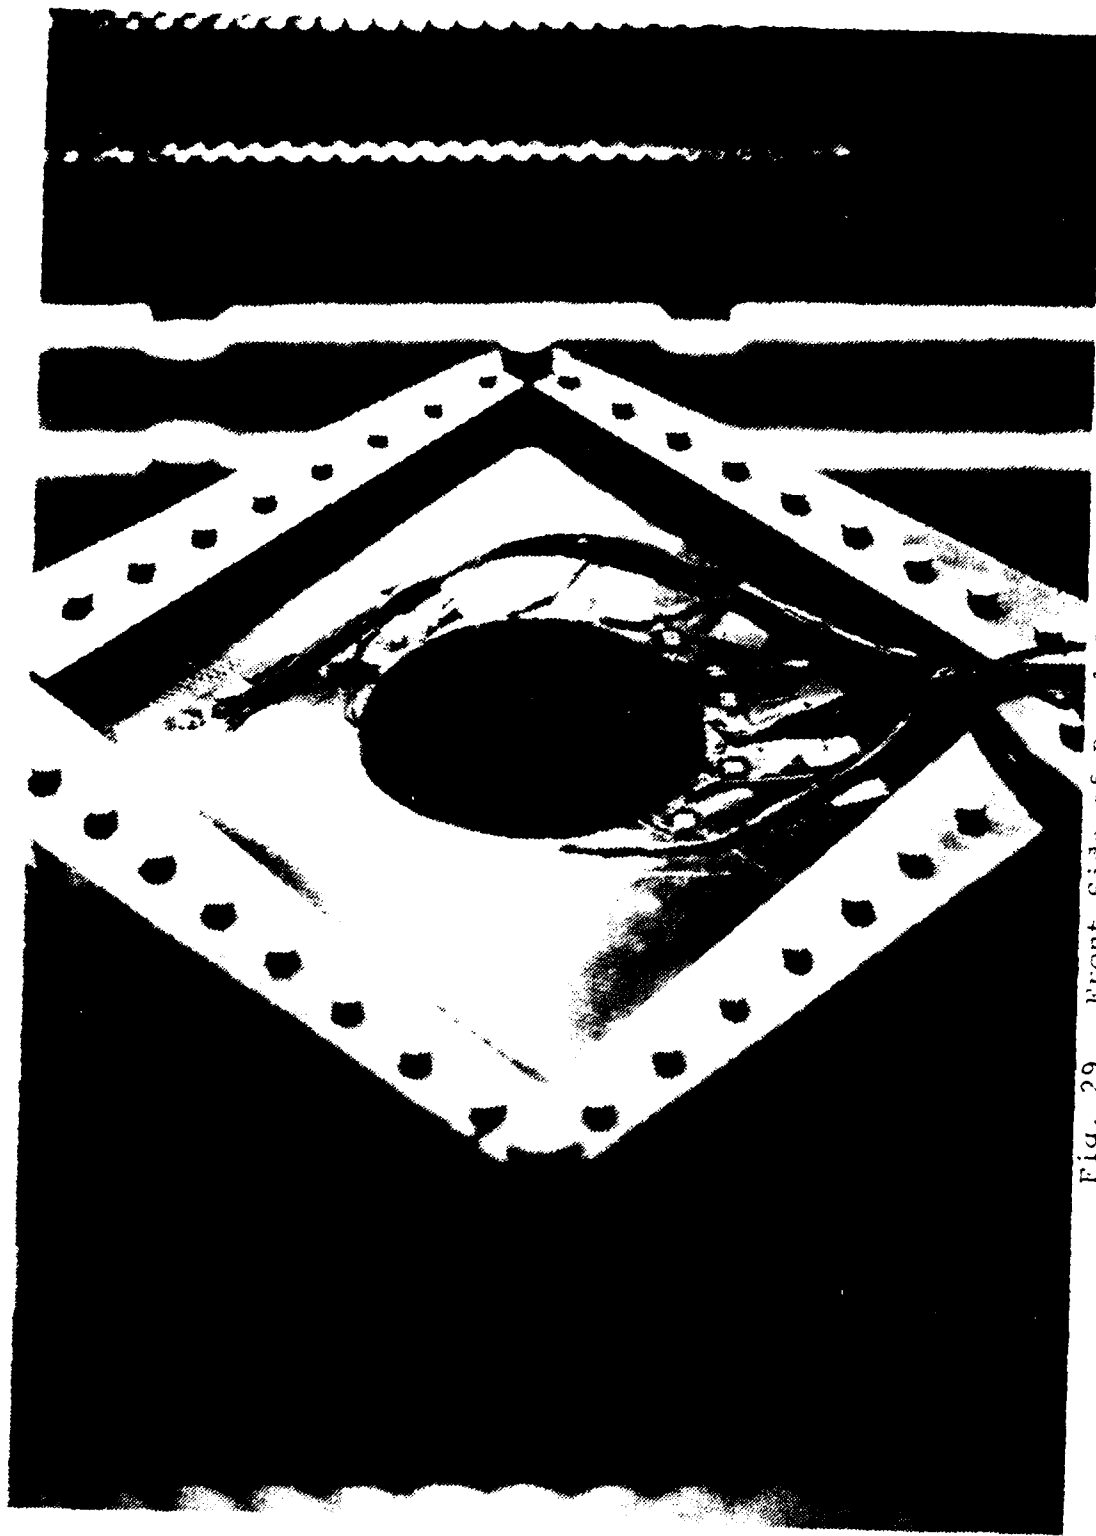
Fig. 29. Front Side of panel 2A at 8000 lb

Small "crackle" sounds were first heard as the machine load reached 5000 pounds. Figure 29 shows the deep buckle down the center of the panel as viewed from the front at 8000 pounds. Immediately after reaching 11000 pounds, a brittle failure with fiber pullout occurred completely through the layup and horizontally across the entire panel. Figure 30 illustrates the front of the specimen immediately after failure. The residual load capability of the panel was only 2000 pounds.
